Assessment of Dam Safety of Coal Combustion Surface Impoundments

Coletto LP, LLC

Coletto Creek Power, LP

Draft Report

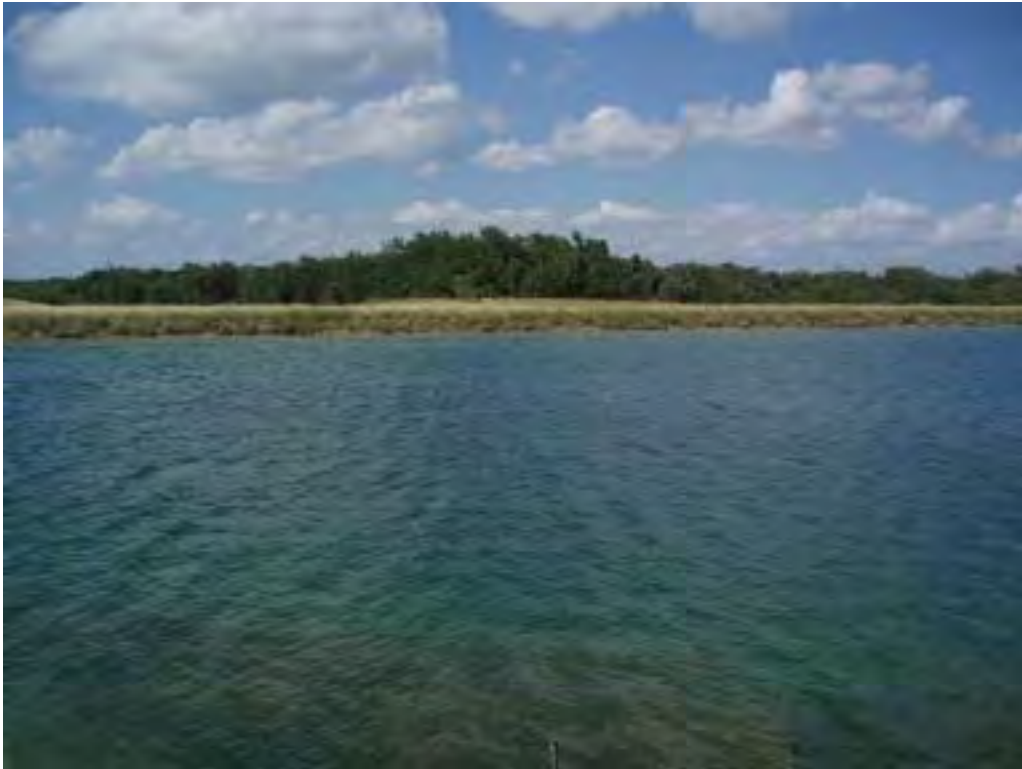
No riprap was observed on the interior slopes. Grass and brush approximately 24 to 36 inches tall was observed growing on the top 1 to 2 feet. Below, the soil was exposed and there was approximately 1 to 2 feet of erosion from wave action (Photos 4 and 43).

Photo No. 5: Secondary Pond - Overview of north interior slope, looking north at typical erosion from wave action. Note approximately 1 to 2 feet of erosion on north interior slope.

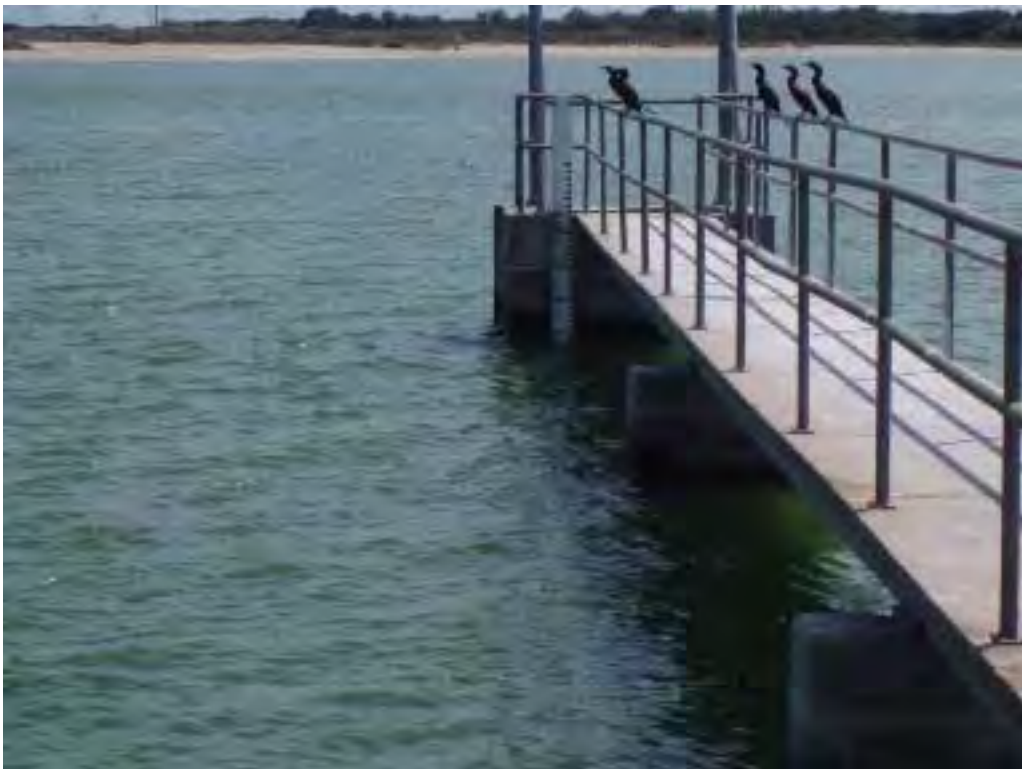
The inlet structure in the Primary Ash Pond appeared to be in fair condition (Photo 6, 7, and 8). The inlet structure was clear of debris. Some cracking in the concrete around the top of the intake structure was observed (Photo 7). The remainder of the structure above the water level and the catwalk appeared to be good condition.

Photo No. 6: Primary Ash Pond - Overview of staff gage and inlet structure, looking southwest. Note water level on 6/21/10 and 6/22/10 was El. 136.8

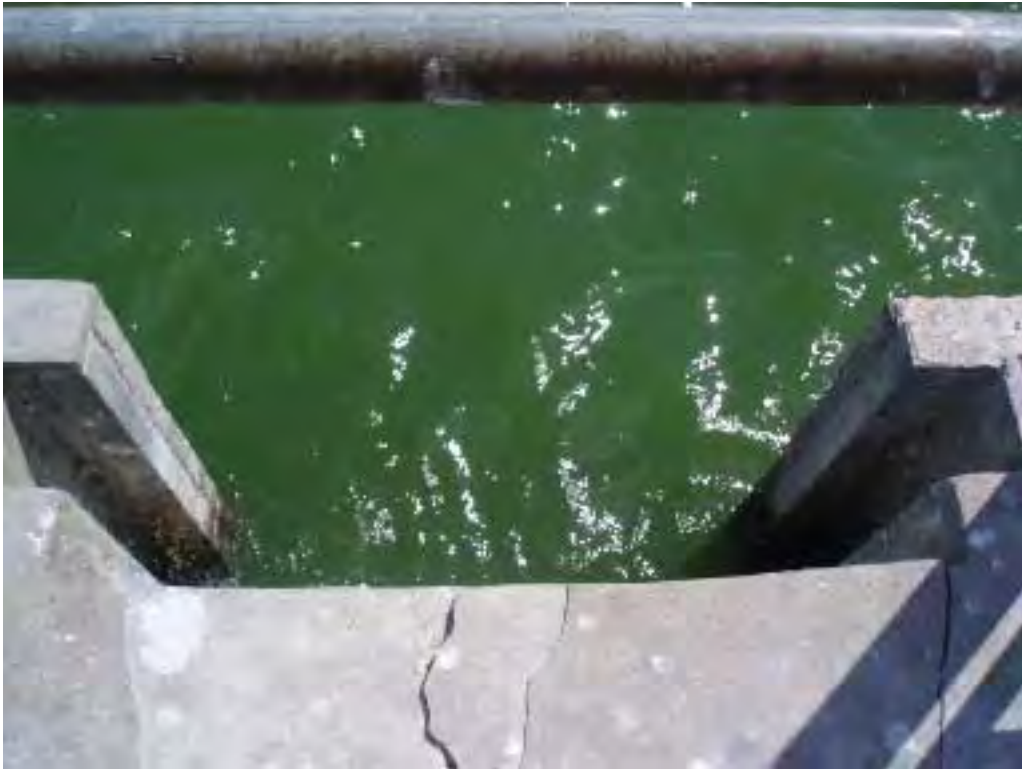
Photo No. 7: Stop-log slots on inlet structure.

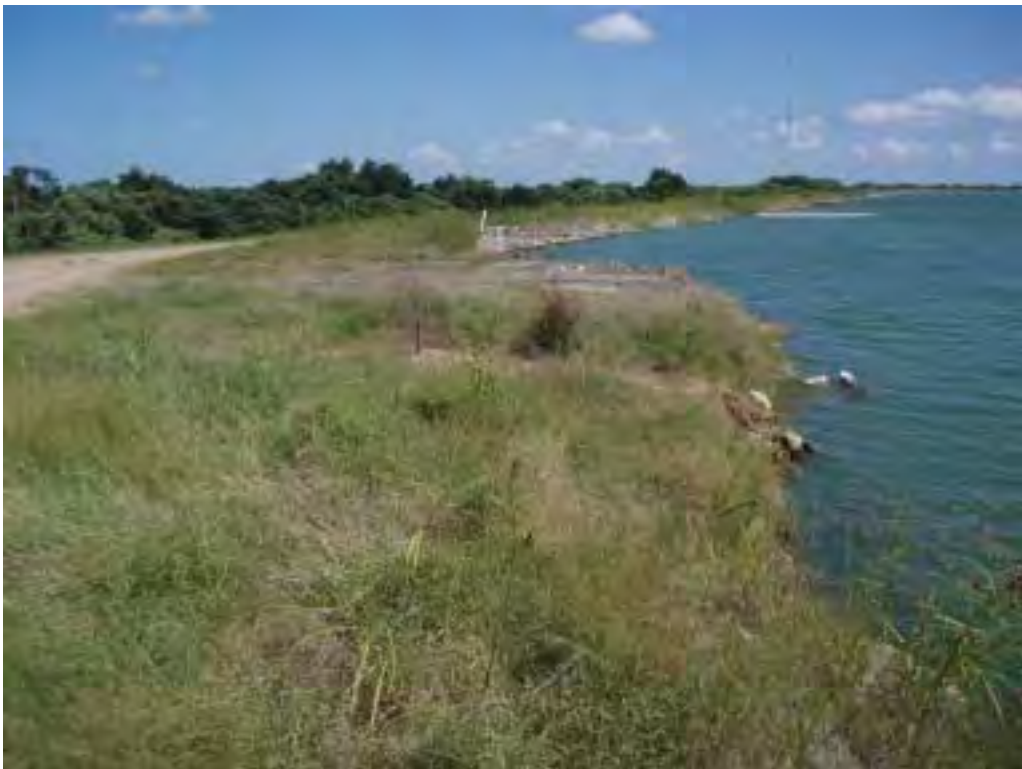
Two areas on the east embankment were observed where BMT has dumped excess flyash and bottom ash and pushed the material into the Primary Ash Pond (Photo 12). No riprap erosion protection was present in these areas.

Photo No. 12: Primary Ash Pond - East interior slope, looking southeast. Note areas where Boral trucks have dumped excess material on the interior slope.

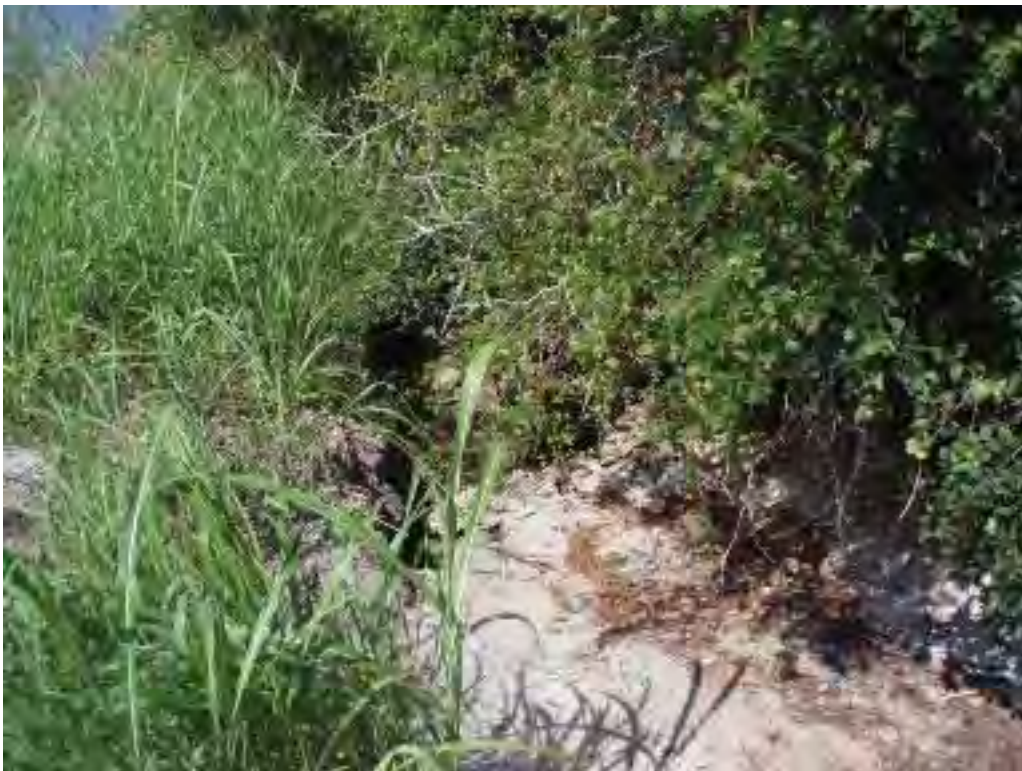
The outlet pipes and recirculating pump station appeared to be in fair condition (Photos 19, 20, 21, and 24). The outfall in the discharge canal appeared to be in poor condition (Photo 22). The discharge channel has deteriorated. The concrete is overgrown with vegetation, cracked and spalled, and sections of the channel are missing exposing the underlying soil.

Photo No. 22: Overview of outfall channel. Note channel is deteriorated. Concrete is cracked, spalled, and missing and there is exposed soil.

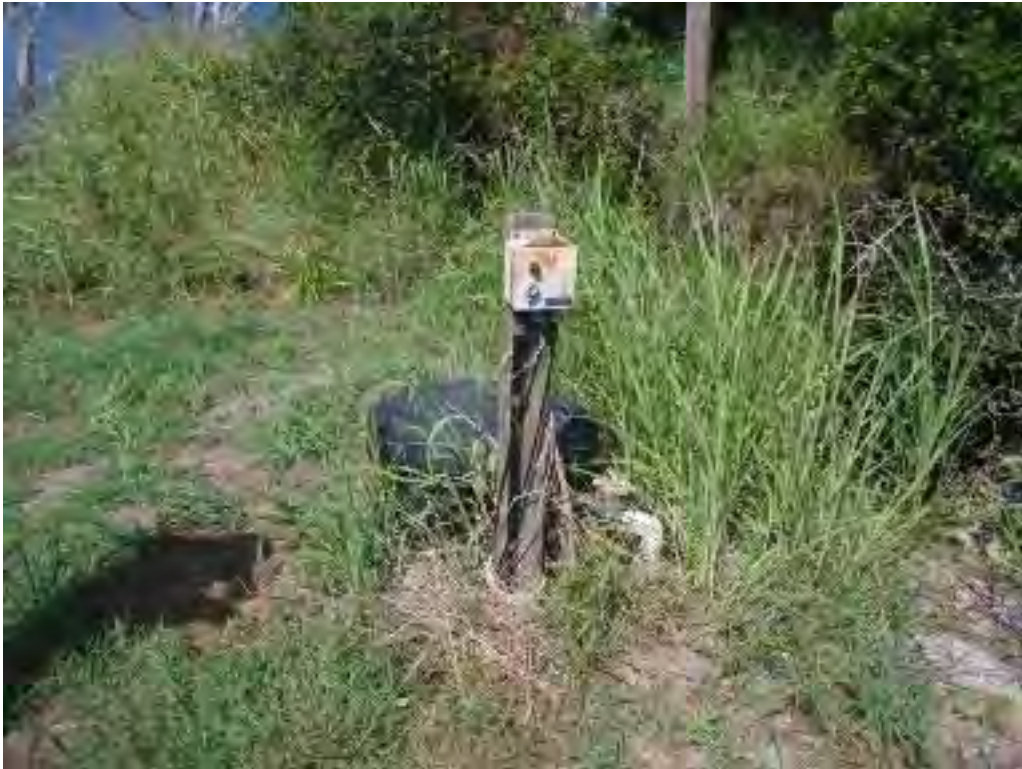
Seepage was observed at the toe of the east embankment exterior toe. The discharge sump for the subsurface drain seepage collection system was observed adjacent to the recirculating pump station (Photo 23). Flow was estimated to be approximately 5 gpm in the sump through a 2-inch-diameter pipe.

Photo No. 23: French drain discharge sump at toe of Secondary Pond near outfall. Estimated flow approximately 5 gpm through a 2-inch-diameter PVC pipe.

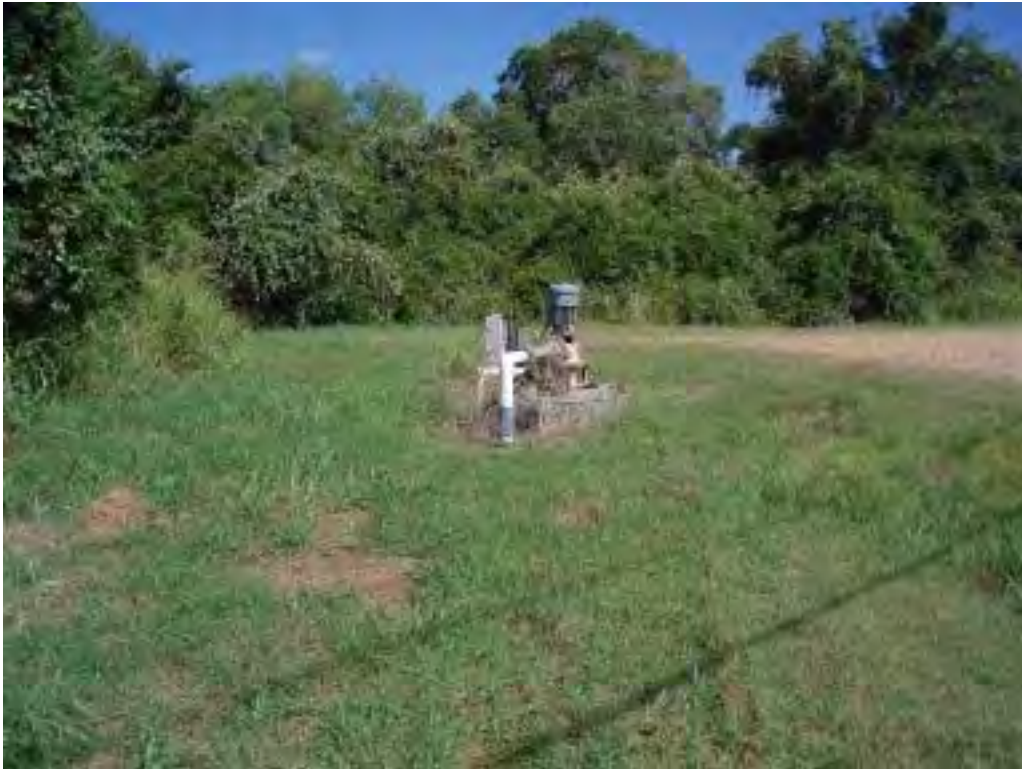
More seepage was observed on the east embankment near the recirculating pump station. The sump pit for a subsurface drain seepage collection system was observed to the south of the pump station (Photo 25). The estimated flow from the sump pit through a 4-inch-diameter PVC pipe was approximately 50 gallons per minute (gpm). A seep was also observed on the inside of the access road to the pump station (Photo 26).

Photo No. 25: French drain discharge sump at toe of Primary Ash Pond east embankment. Estimated flow approximately 50 gpm through a 4-inch-diameter PVC pipe.

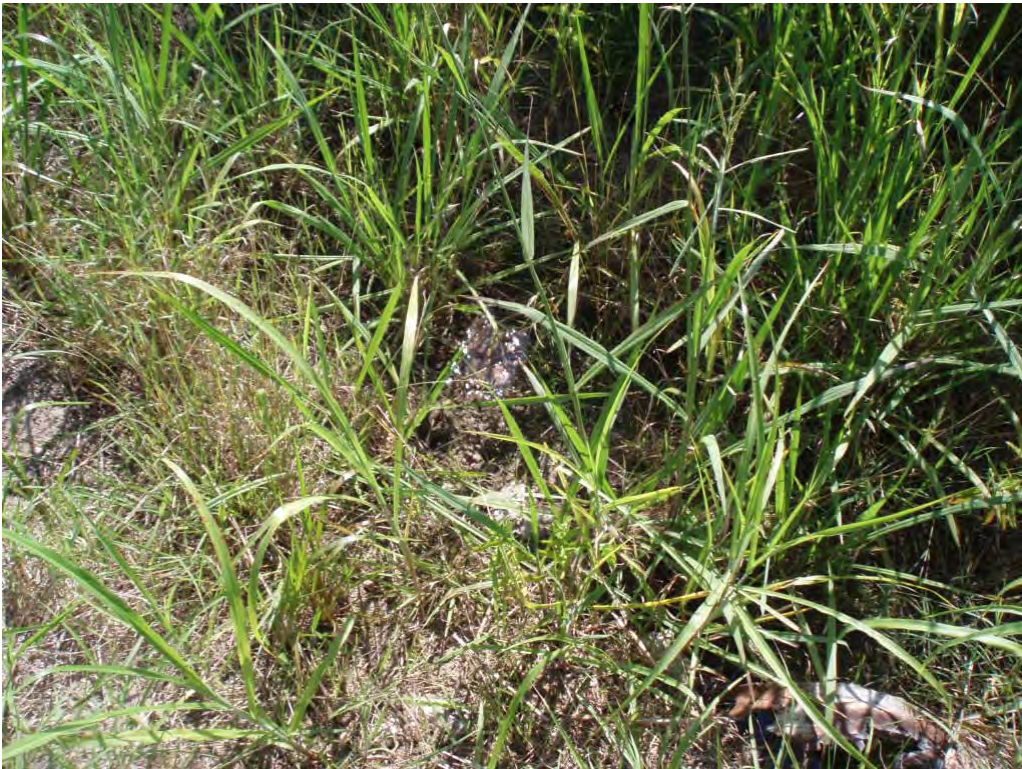
Photo No. 26: Primary ash pond – East embankment exterior slope, looking at seepage at toe near French drain.

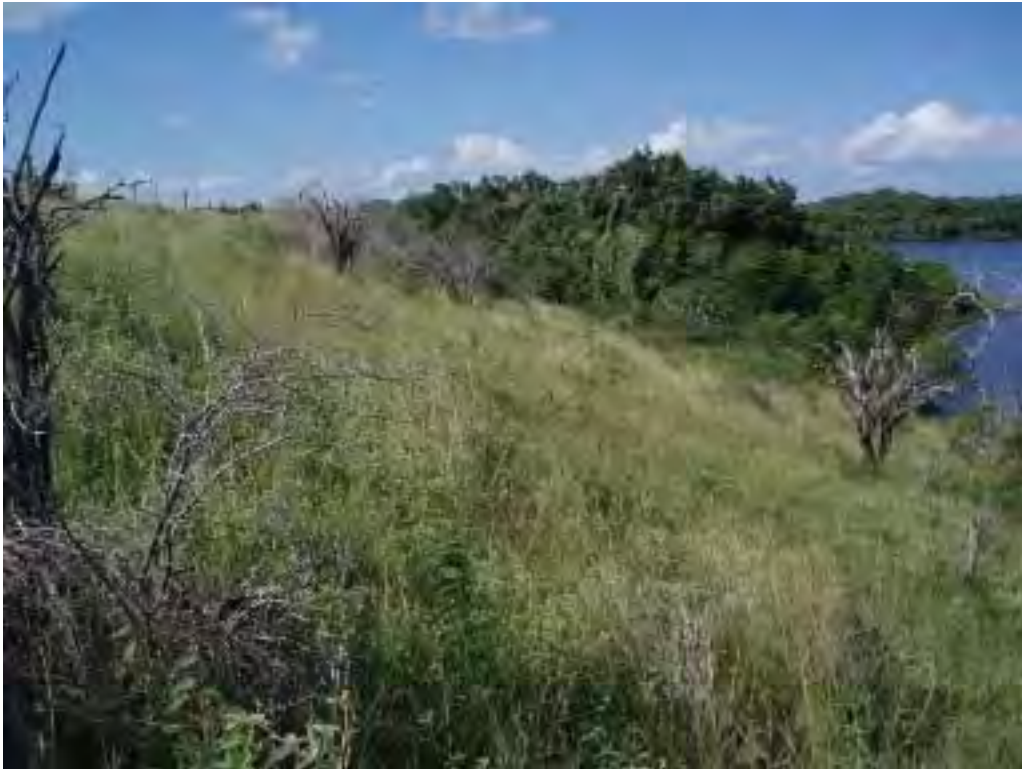
Photo No. 27: Secondary Pond – East embankment exterior slope looking northeast. Note 8- to 12-inch-diameter dead mesquite trees on the slope.

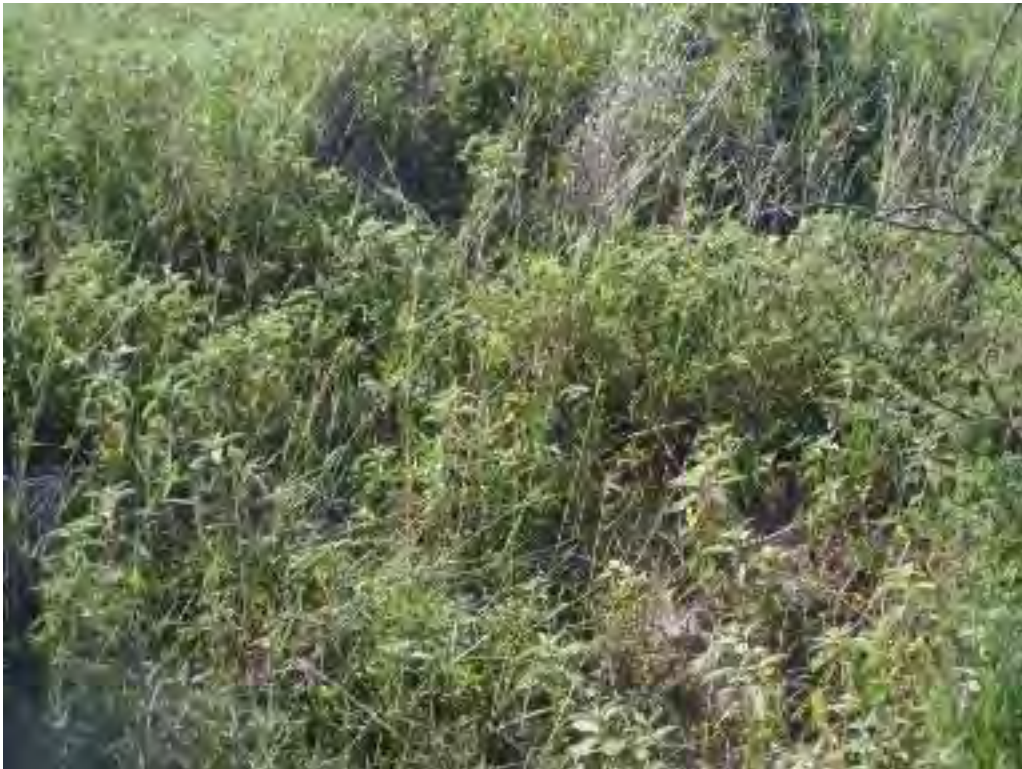
Multiple depressions were observed on the north and east embankment exterior slopes (Photos 28, 30, 31, 32, and 36). The depressions ranged in size from 4 to 8 feet long and up to 3 feet deep. The depressions appear to be grown in erosion rills because no displaced material was observed below the depressions. Multiple erosion rills were observed at the toe of the north embankment exterior slope (Photo 33, 34, and 36). The erosion rills ranged in size from 6 to 10 feet long and up to 3 feet deep.

Photo No. 28: Secondary Pond – East embankment exterior slope, looking at 4'Wx2'D depression.

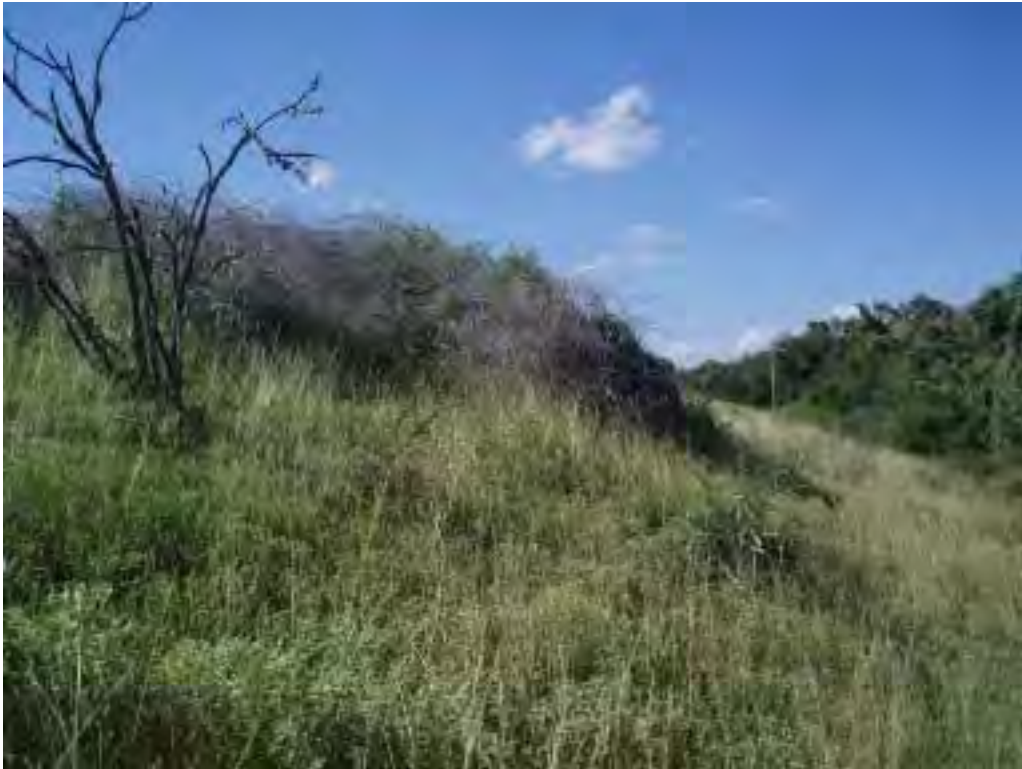
Photo No. 29: Secondary Pond – East embankment exterior slope, looking north at thick brush and dead trees.

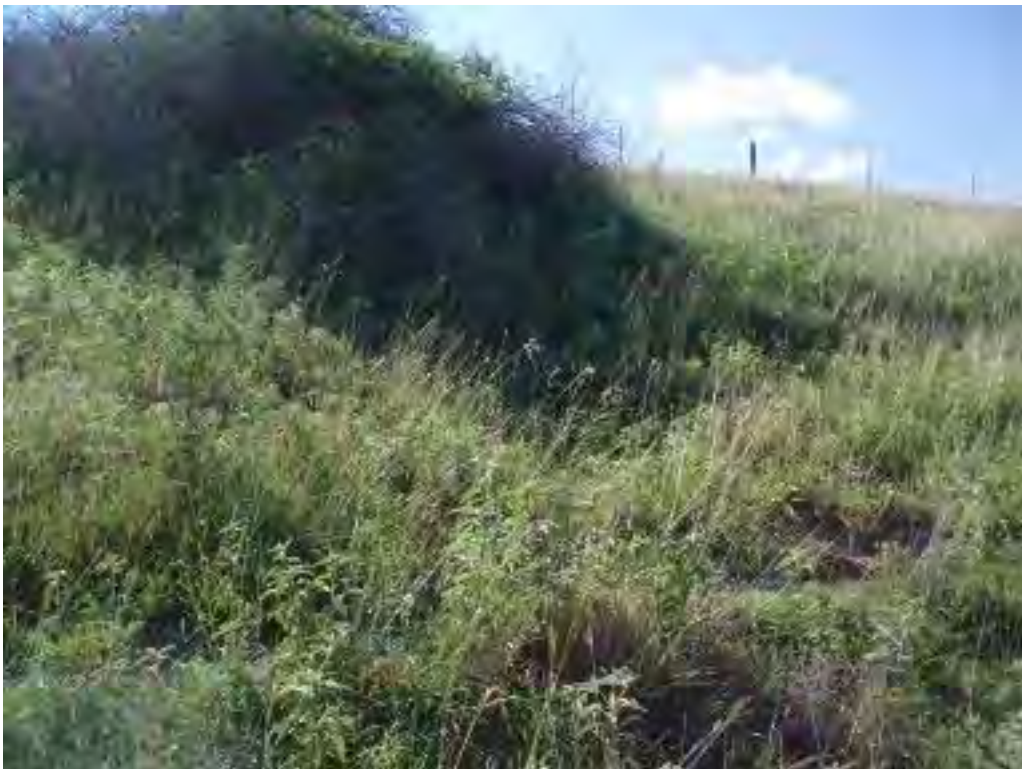
Photo No. 30: Secondary Pond – East embankment exterior slope, looking at 8'Lx8'Wx2'D depression.

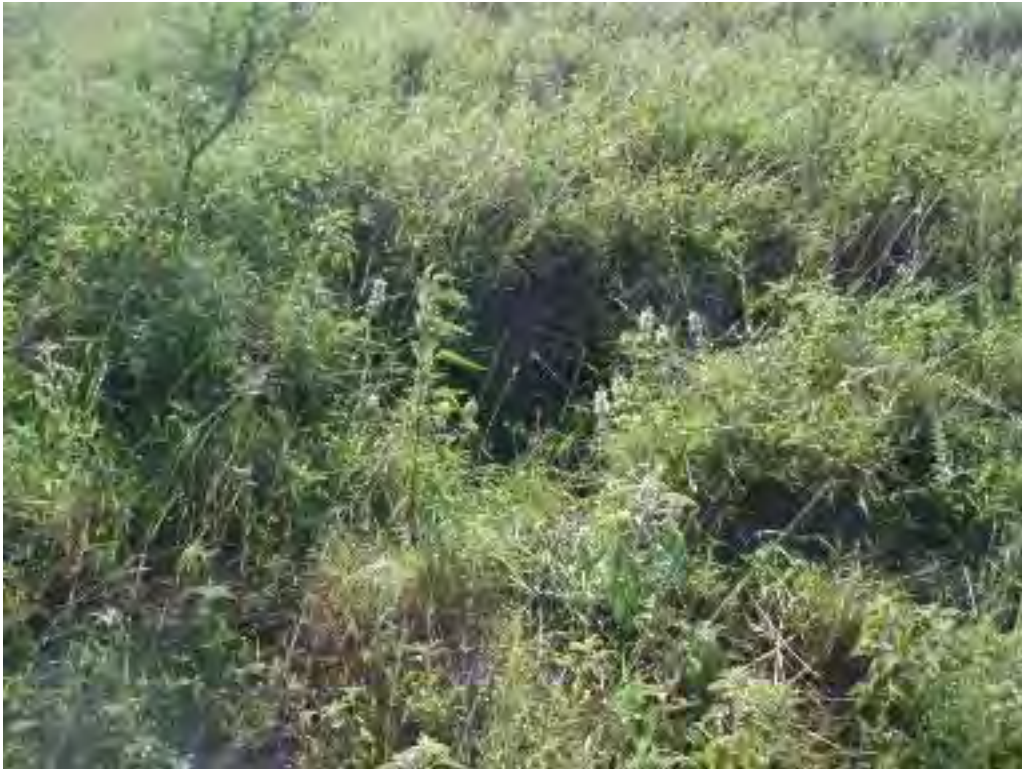
Photo No. 31: Secondary Pond – East embankment exterior slope, looking at 6'Lx4'Wx3'D depression.

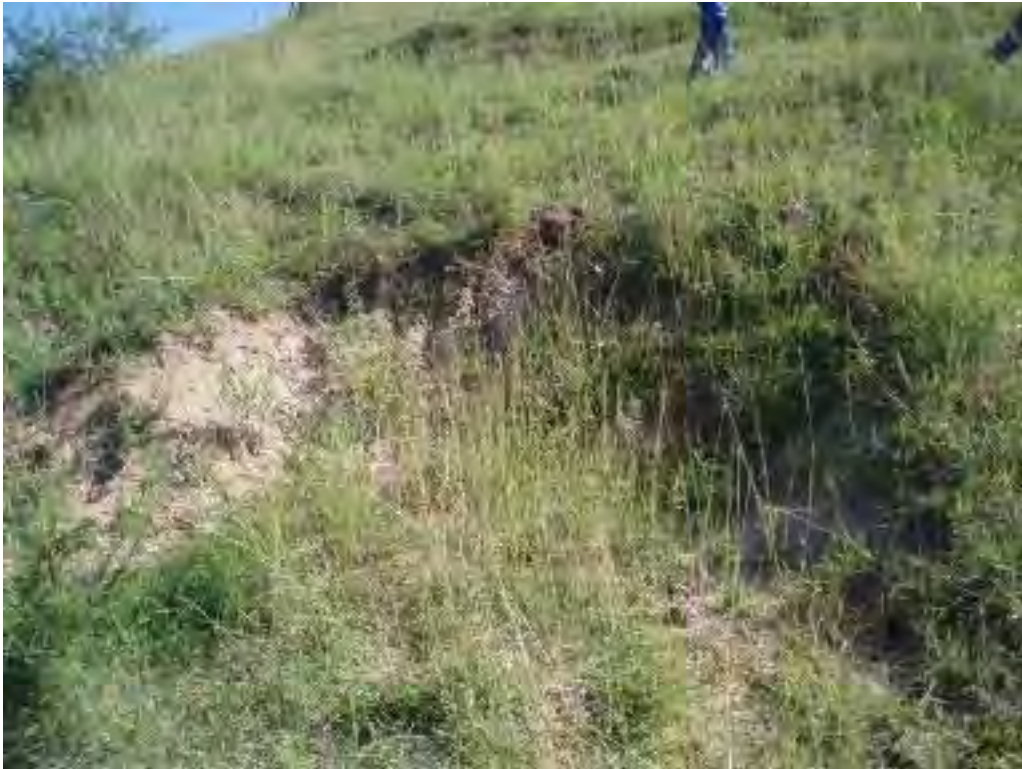
Photo No. 33: Secondary Pond – North embankment exterior slope, looking at 10'Lx4'Wx3'D erosion rill. Note the brush in background.

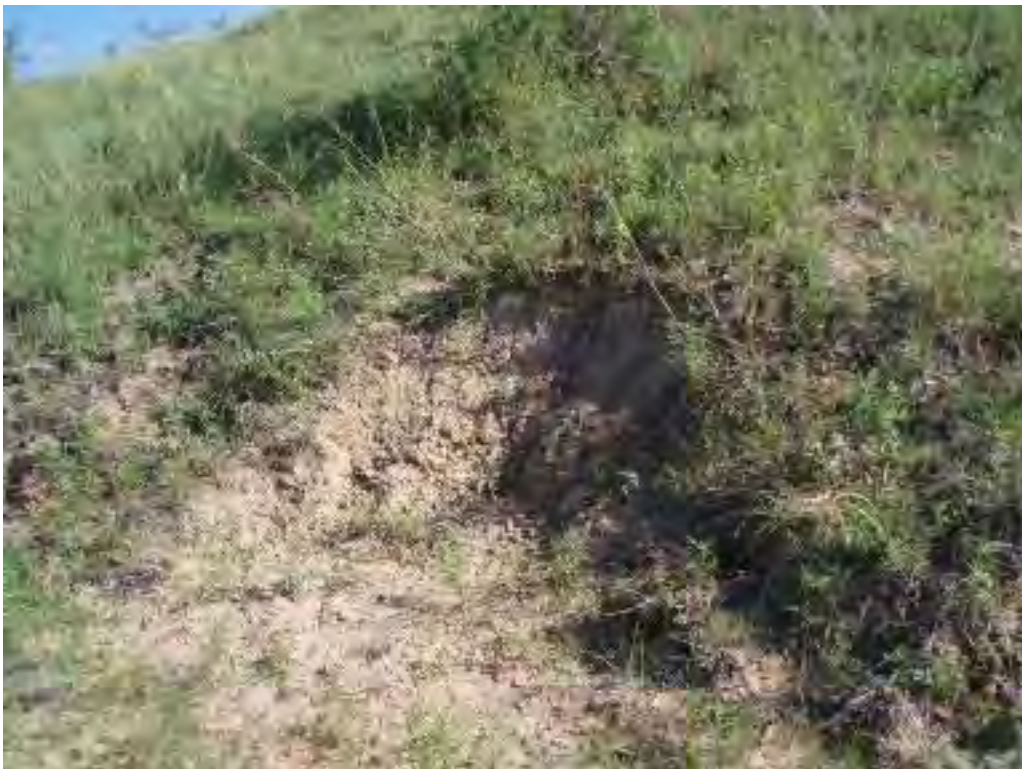
Photo No. 34: Secondary Pond – North embankment exterior slope, looking at 8'Lx4'Wx2'D erosion rill.

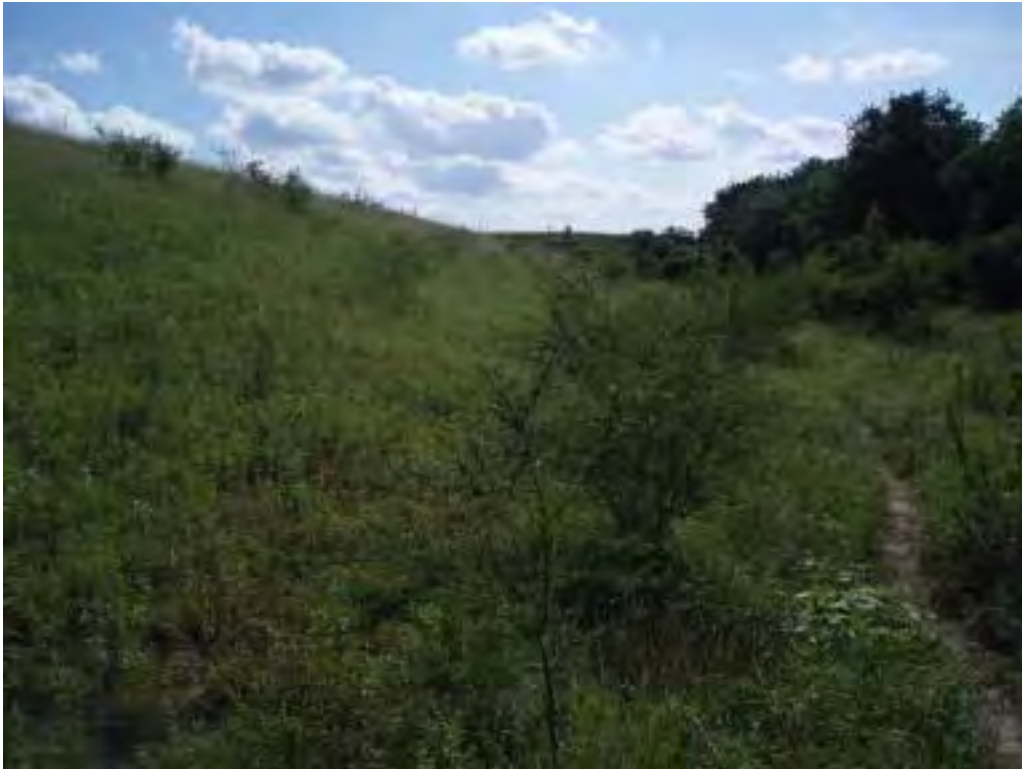
The exterior slopes appear to be in fair condition. The exterior slope on the north and east embankments were approximately 3H: 1V (Photos 18, 27, 29, 32, 35, 37, 38, and 40). Embankment vegetation consisted mainly of grass approximately 36 to 48 inches tall. On the east embankment, 8- to 12-inch-diameter dead mesquite trees and an area of thick brush were observed (Photos 27, 29 and 30). On the north embankment, small brush and mesquite trees less than 2 inches in diameter were observed (Photos 33 and 35).

Photo No. 35: Secondary Pond – North embankment exterior slope, looking west. Note trees and brush growing on the slope.

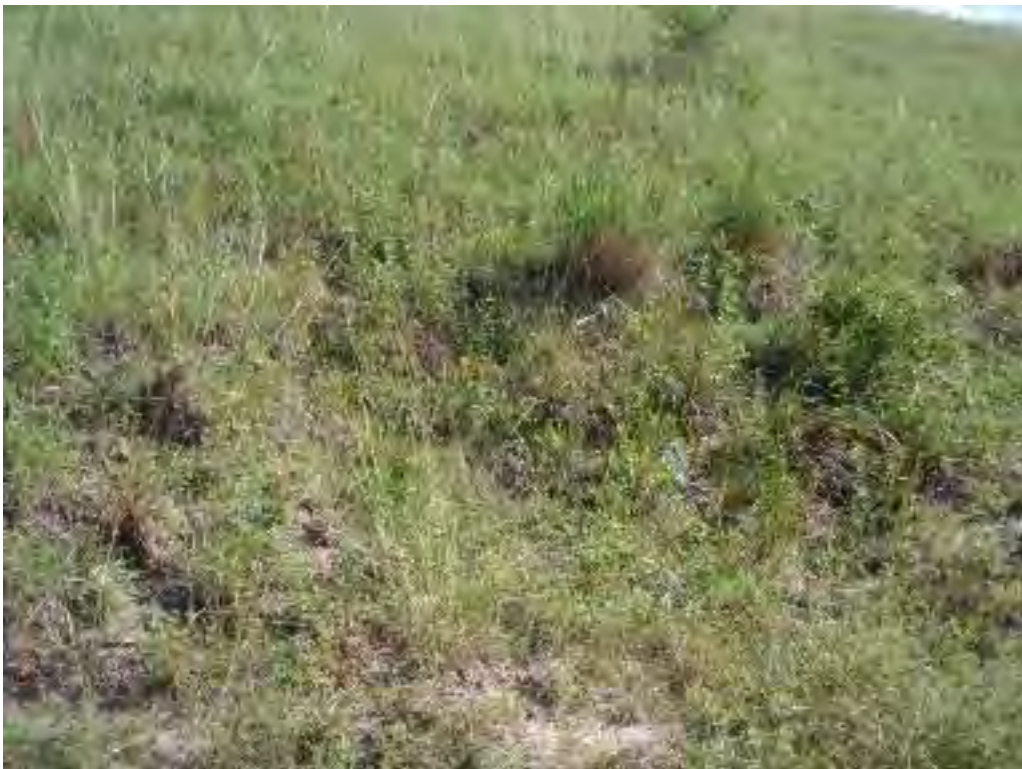
Photo No. 36: Secondary Pond – North embankment exterior slope, looking at 6'Lx4'Wx2'D erosion rill.

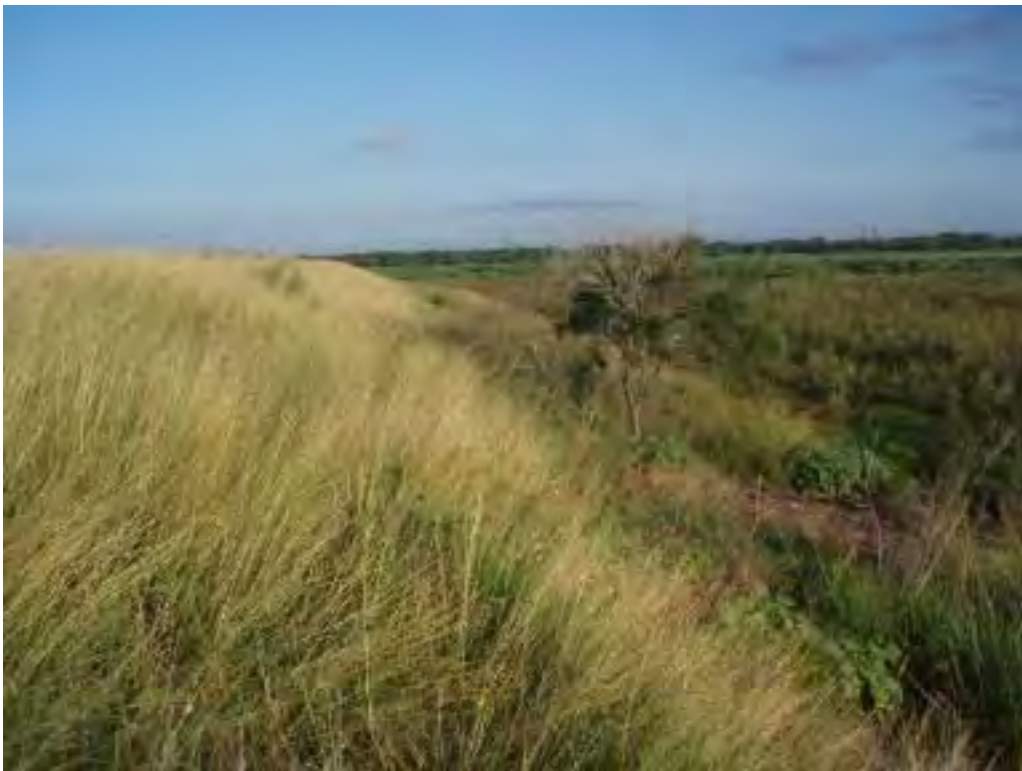
The north, west, and east embankments were generally covered with grass and small brush approximately 24 to 48 inches tall. On the north and west embankments there were 6- to 12-inch-diameter mesquite trees on the slope (Photos 52, 62, and 66). Smaller mesquite trees, 1 to 2 inch inches in diameter were observed on the east embankment. On the north embankment, areas of well established vegetation were observed (Photo 53). The southwest, south, and southeast embankments were covered with grass approximately 6 to 12 inches tall.

Photo No. 52: Primary Ash Pond – North embankment exterior slope, looking west at tall grass and 6-inch-diameter mesquite tree.

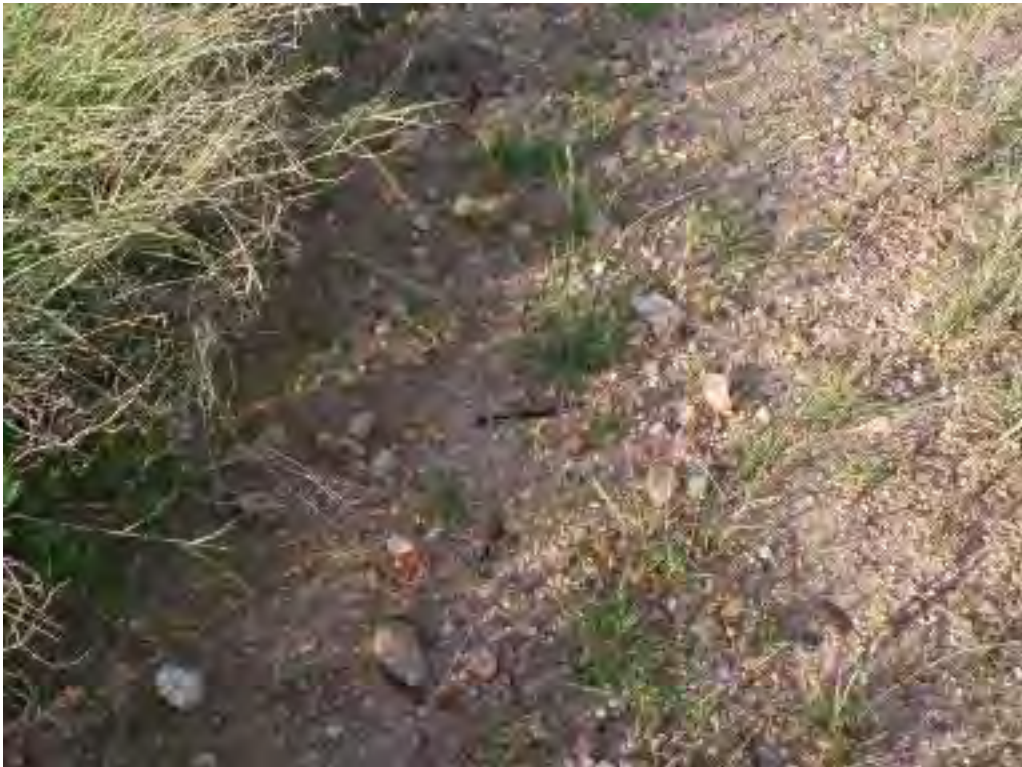
Photo No. 68: Primary Ash Pond – West embankment crest, looking at typical desiccation crack.

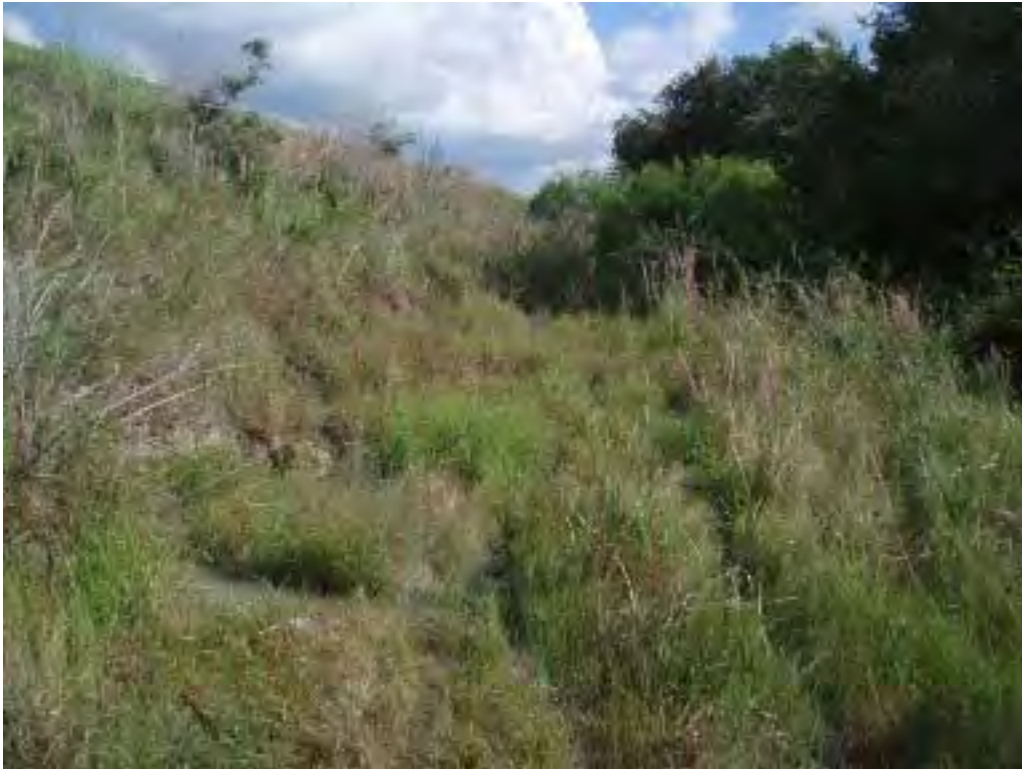
Photo No. 107: Primary Ash Pond – East embankment exterior slope, looking north at beginning of approximately 400-foot-long seepage area. Note area is saturated, soft, with standing water and lush vegetation. Isolated hog wallows were observed in the seepage area.

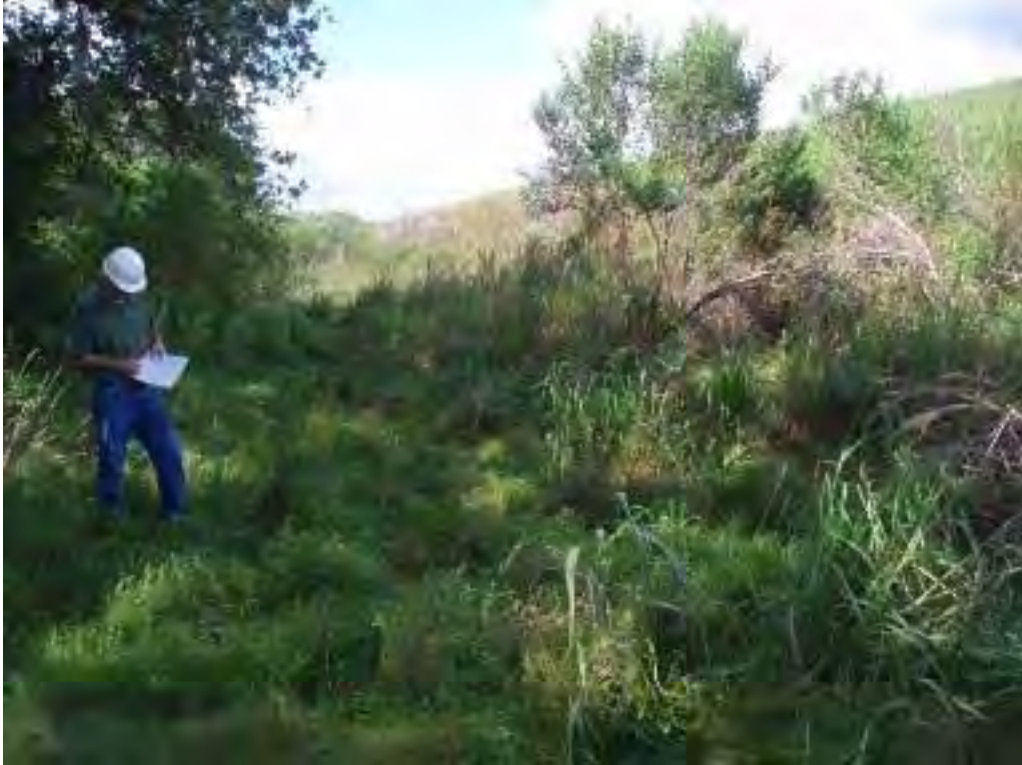
Photo No. 108: Primary Ash Pond – East embankment exterior slope, looking south at end of approximately 400-foot-long seepage area.
